SECTION 8 POOL FINISH

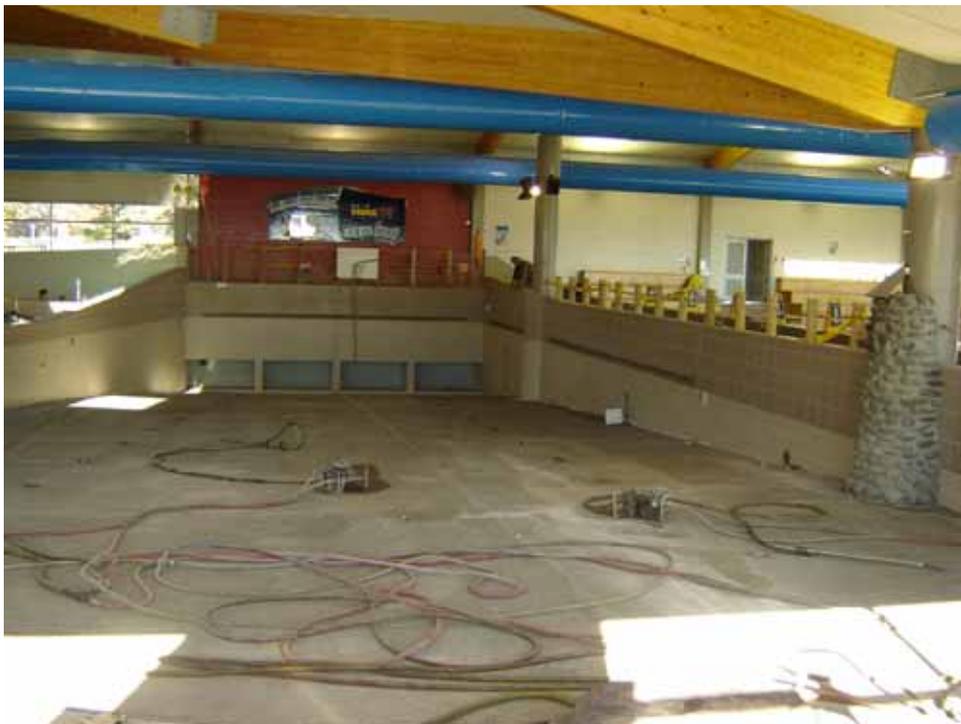
One site has experienced continual problems with its learner pool mosaic tiles coming off. Regardless of replacing sections of mosaics over many years the problem still exists. While the contractor is meeting the cost, it is a nuisance to the pools operation. The Richmond Pool, opened in September 2004, has had the wave and lap pool closed for retiling due to the contractor not following contract specifications.

Richmond wave pool tile replacement

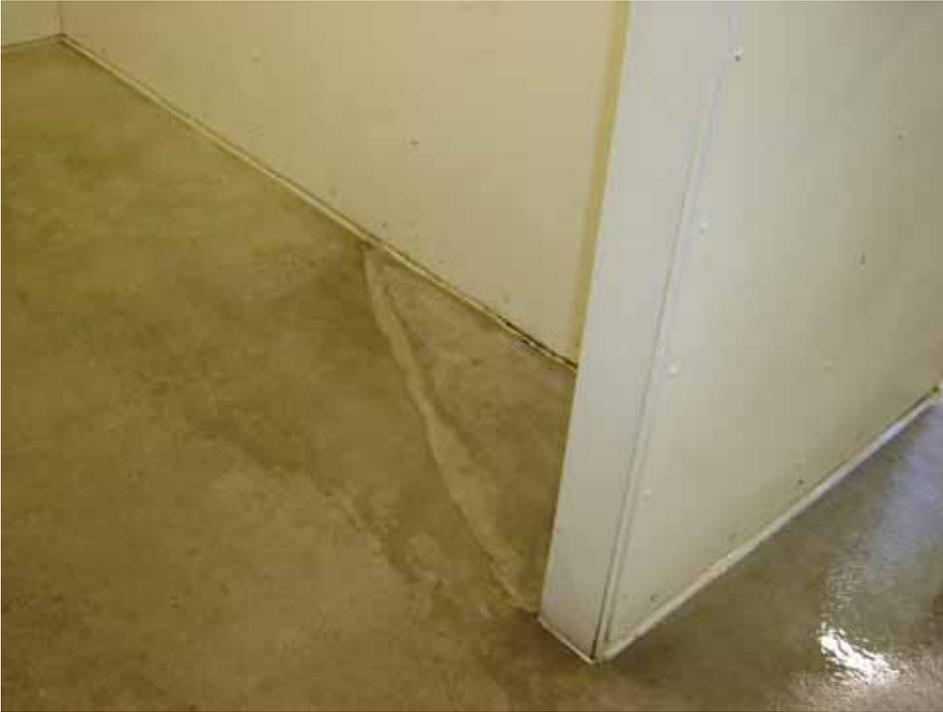
Another site had attempted to rectify the poor fall on change room floors by adding to the concrete floors around walls and corners to improve the run off of water. (see photo) This resulted in an obvious patch up job that does not appear to work. The photo also shows a timber dividing wall extending to the floor when I would have thought a gap to allow for cleaning and air movement would have been a better solution.

A patch up job on a changing room floor with inadequate slope

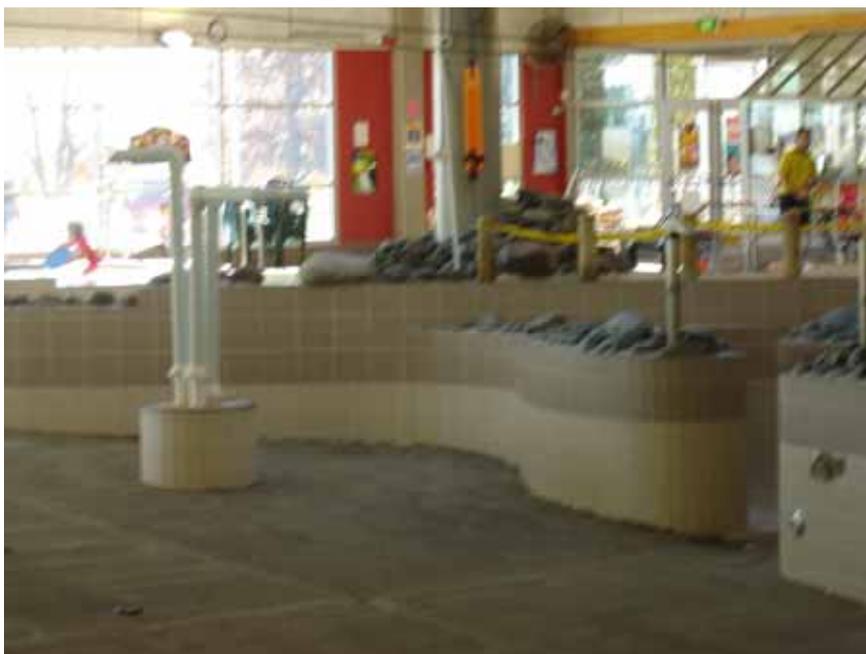
- Non-slip, heavily grooved tiles also make cleaning difficult and time consuming due to dirt being trapped within the tile grooves.
- While not a problem, the Richmond leisure pool had an interesting choice of fawn coloured tiles. As this pool was empty for tile repairs the effect of these tiles could not be judged.

Richmond Pool under repair

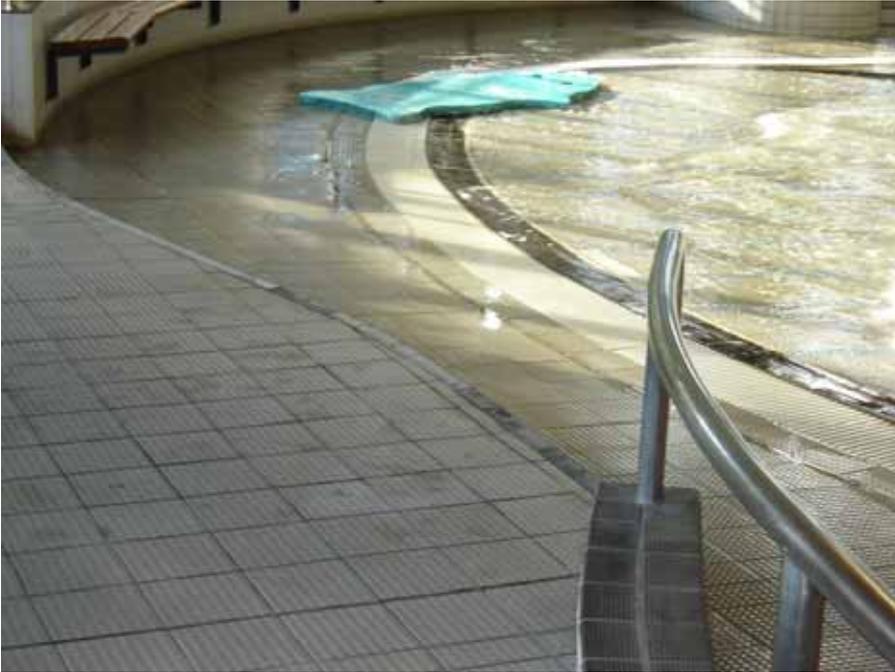
- Inadequate drainage due to poor floor fall and undersized drains around poolside and change areas resulting in pooling of water. I cannot understand how this can occur. Adequate fall is an essential part of pool design and construction and is easily achieved.
- Upper Hutt has experienced problems with mosaic tiles lifting from the toddlers' pool floor over a number of years. (detailed at the start of this section)
- Poolside wash-down water flowing back into the pool overflow channels. Separate drainage must be provided for this function. Poolside wash down water from cleaning of the pool surrounds should not be going into the pool water or the overflow channels for the obvious reasons of hygiene and added pressure on the filtration system.

Poolside wash-down water flowing into pool over flow channels
