## **SECTION 5      DESIGN ISSUES**

## 2. Common Mistakes

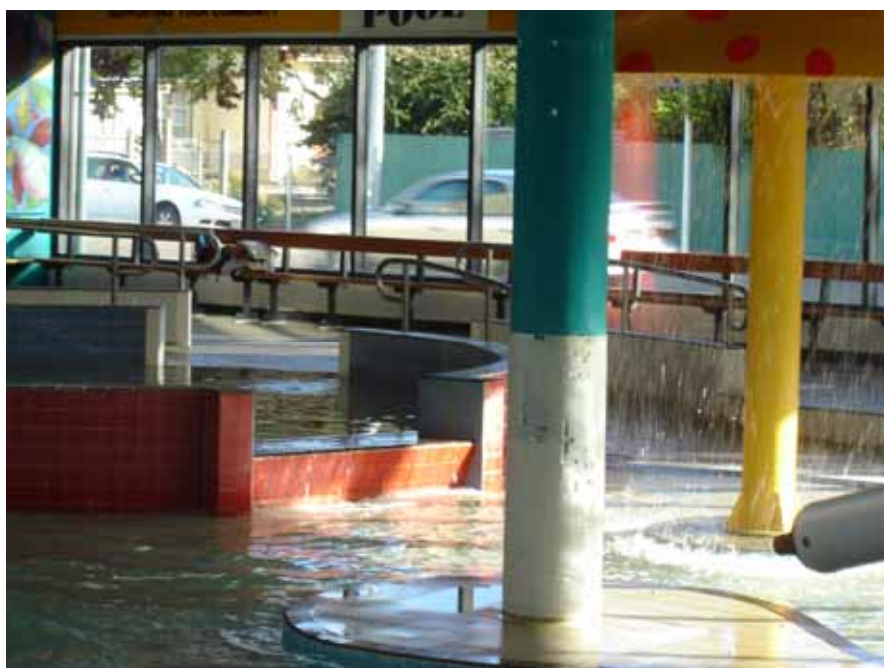
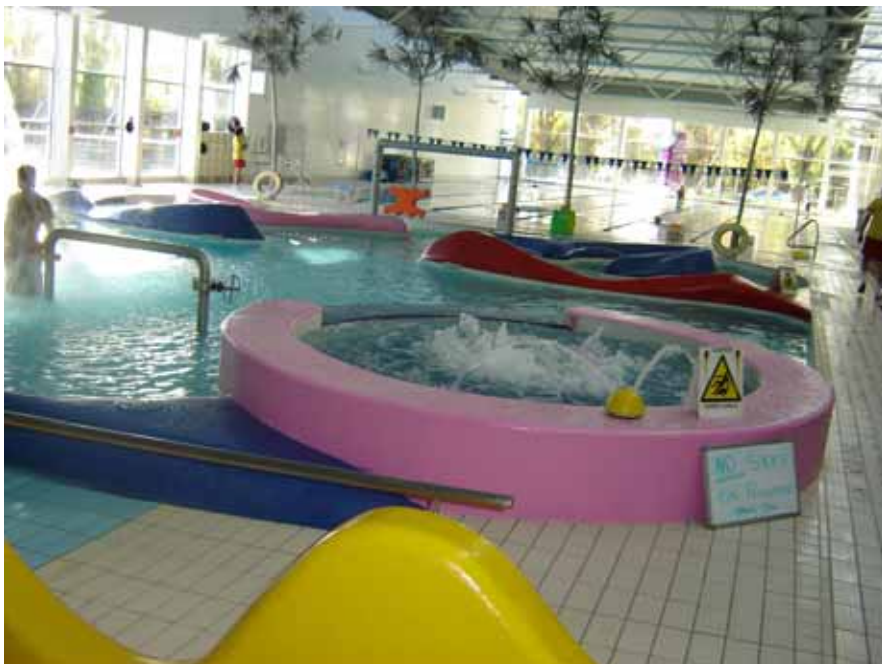
- Two facilities had high temperature water flowing from toddlers or spa pools into leisure pools. It is accepted that the higher the water temperature the likelihood of increased levels of bacteria will be present. These sites therefore could be transferring bacteria into much larger volumes of pool water. Put very simply, the warmer the water, the more it needs to be filtered. A toddler's pool may need to have the entire volume filtered every 30 minutes. NZS 4441 states turnover times for specific pools, these are however, in my view inadequate. I have strongly suggested a total review of this standard. (See Section 10.)

Two examples of high temperature water flowing from the Toddlers' or spa pool to the leisure pool.

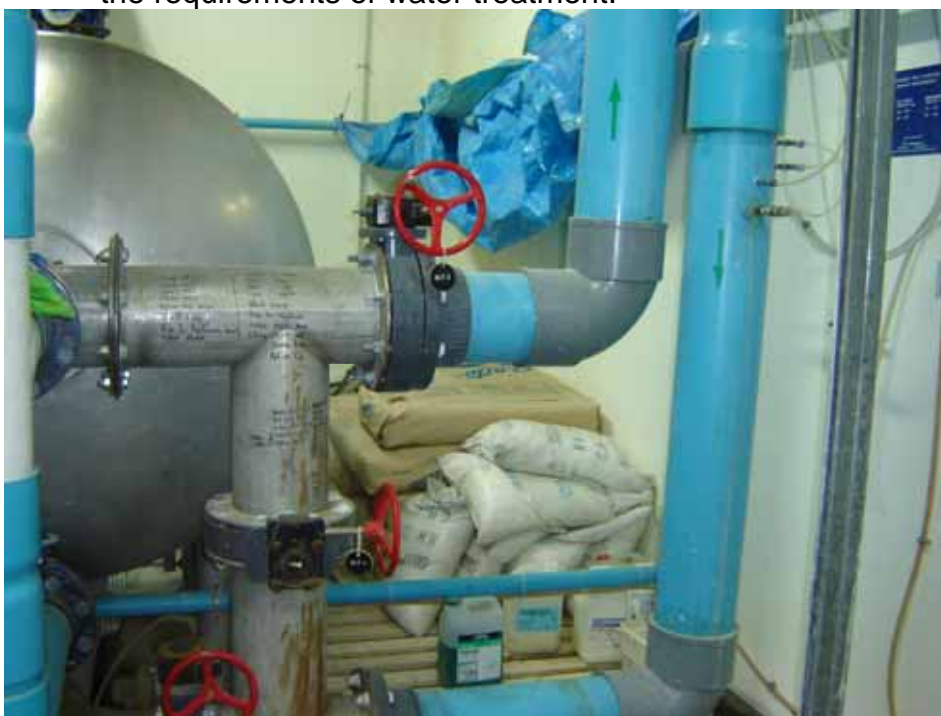
- There was inadequate provision in many plant rooms for the storage and mixing of pool chemicals. These items need to be stored near the delivery point and close to where they are to be used. It becomes a Health & Safety issue when 25kg bags of DE are carried over pipes and around plant rooms. This is both hazardous to staff and unnecessary. Half the sites visited had poor provision for either storage or mixing of chemicals and suggests to me that some designers have little concept of the requirements of water treatment.

An example of poor provision for chemical storage.

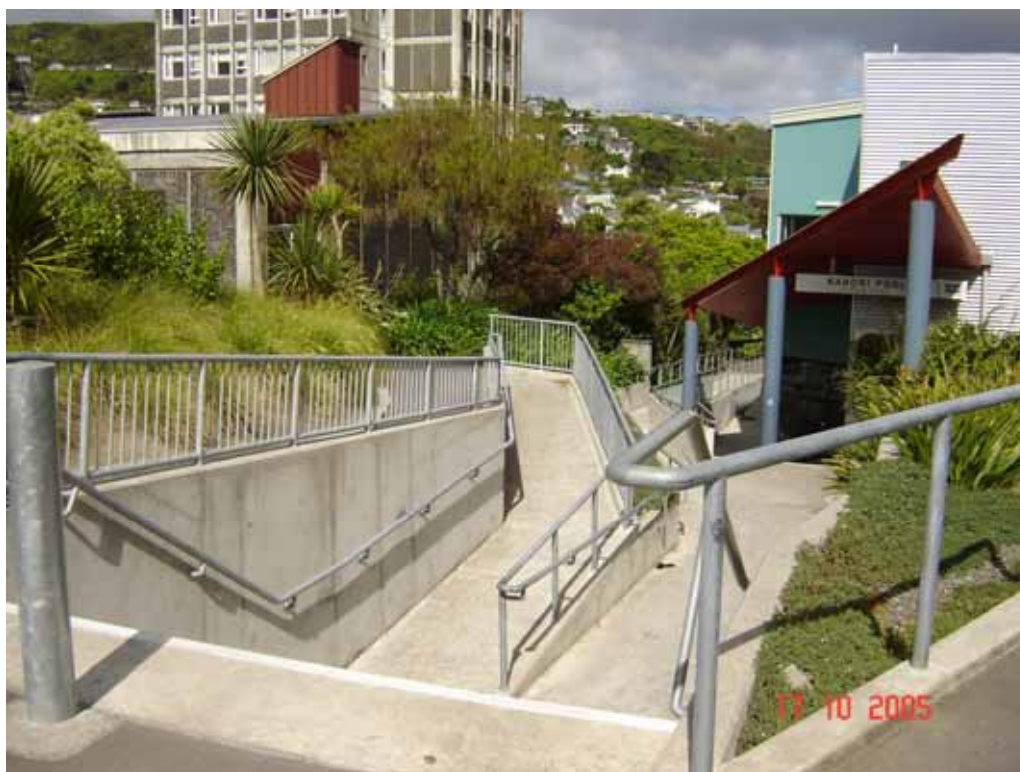
- While all facilities provided for disabled access, two had doors that were too heavy for disabled people to open. Another had ramp access from the car park to the facility steeper than the required 1:12 ratio. (see photo next page)

Access challenge for pool clients

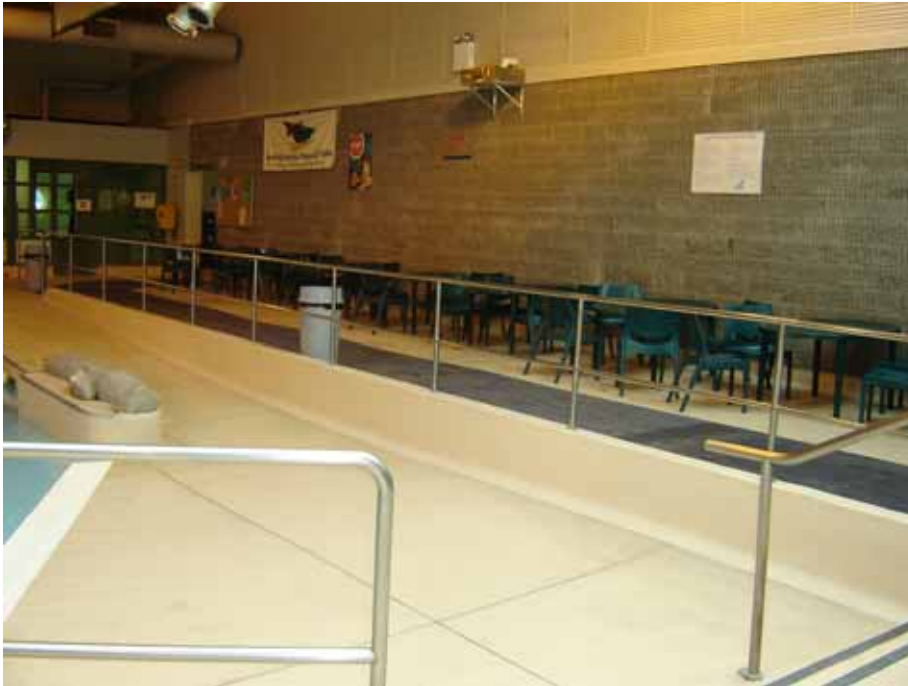
- Two pools had inadequate poolside space for spectator seating and foot traffic flow. The distance from seating or external wall to poolside was in some cases less than a metre, which does not allow much room for pushchairs or wheel chairs. Anecdotal evidence suggests that this limited and cramped space discourages public use. Family changing room doors opening out to block the passage way could have been overcome by installing sliding doors.

Restricted walkway between hand rail & wall.

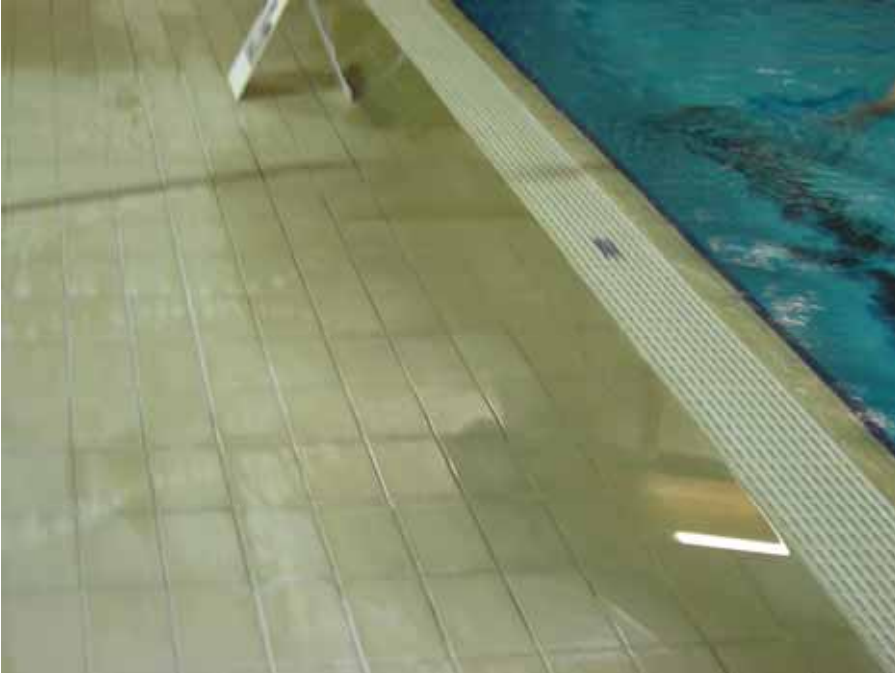
- There were many examples of poor floor drainage, not enough slope and / or too small drainage outlets. One pool had no drainage provision at all in the family change rooms. Drainage takes on much more importance in the swimming pool environment. Water that ponds will produce rot in all but the most durable materials and fosters the growth of bacteria and disease aided by the warm temperature and high humidity of an indoor pool. Just as important is ensuring that customers don't have to walk through puddles of water on their way to change areas or to poolside.

- Poolside pooling of water.
- looks unsightly, discolours tiles, requires continual cleaning and is a safety hazard.

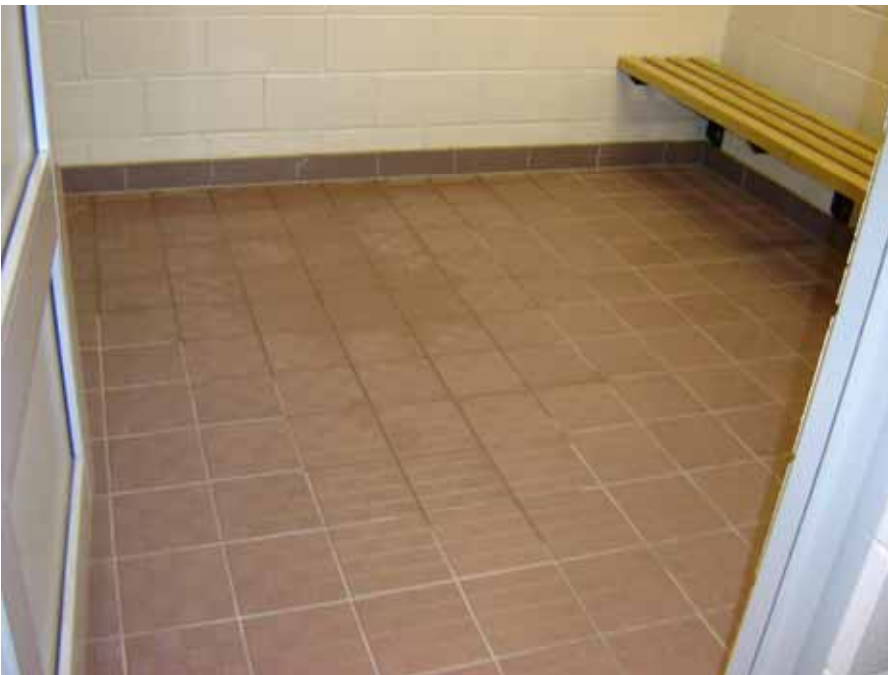
No drainage and poor fall in family change room.
