SECTION 9 CAPITAL COST / OPERATING COST

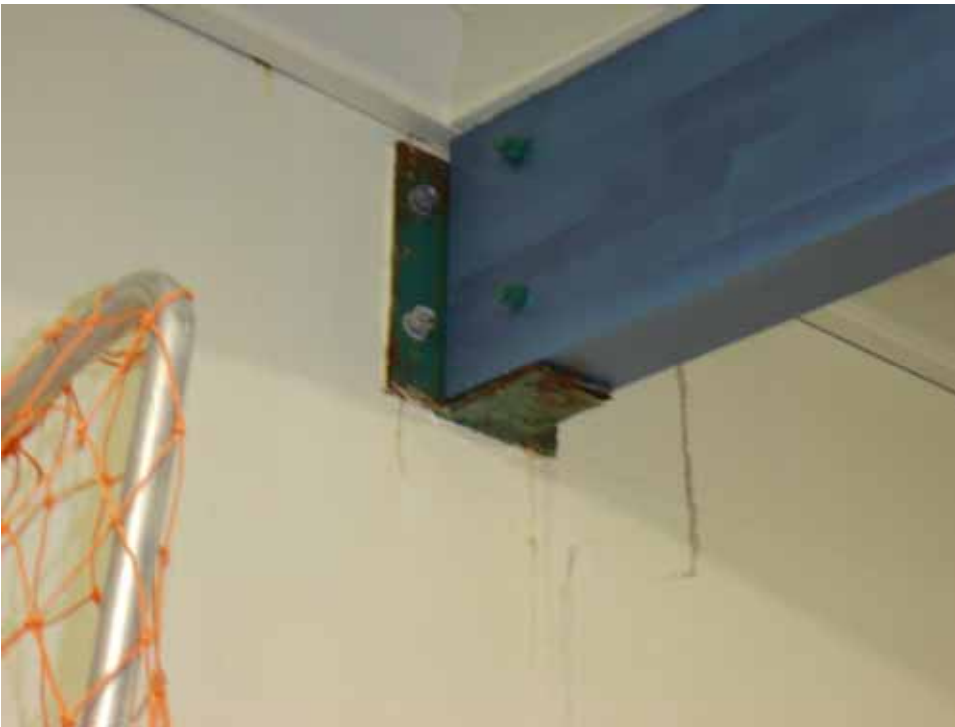
Either poor choice of materials or poor design, or a combination of both, with bad condensation problems resulting in corroded steel beams and supports in almost half of the facilities visited. (See Section 7) Three pool managers mentioned the use of mild steel within their facilities, resulting in continual maintenance. Any steel immersed in or near chlorinated water should be stainless steel 316 grade.

Corroded steel supports.

If cost was the reason for deciding on the use of mild or even galvanised steel within the pool building then it is a false economy in terms of ongoing maintenance costs this is a typical example of little or no consideration being given to the ongoing and ever increasing running costs of pool facilities.

1. That switch boards are housed separately in a ventilated room.
2. Stainless steel 316 grade is used within the pool hall on all fittings and fixtures.
3. Allow for future additions at the design stage. Attractions may not be affordable initially, allowing for them in the future will create savings.
